## Tests Août 2004

### Avant installation définitive

### Avec Slow Control Epics + Minidag LabView

### Pas de polarisation HT – Une seule face lue à la fois.

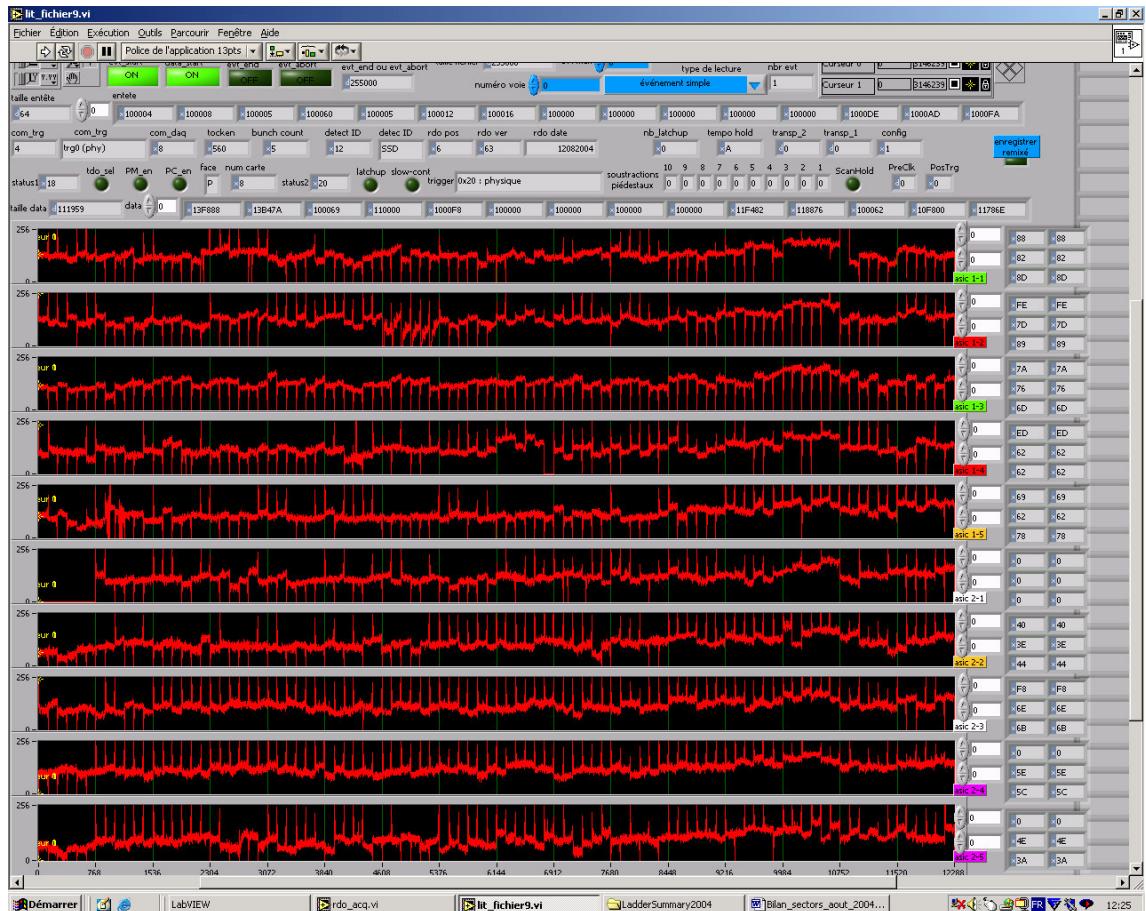
A3 to A6 missing on H15. OK with bias parameters changed except A1 with high ped. A1 is sometimes ok when it has its bias set to the nominal value

H4 missing. Back with force bias.
